## **1978 Catalina 30 Hull Number CTYN0987M78F Refit Preparation of Engine Compartment for Replacement of Engine**

The Atomic 4 in this Catalina 30 will be replaced with a Moyer Marine Inc. exchange engine. There were two cracks in the fiberglass comprising the engine compartment surround, and there was crack in the supporting block on the starboard side under the engine access panel. It seems desirable to install many items on the engine compartment walls (heat exchanger, oil filter, gas filter, ...) and so I assumed it made sense to reinforce the engine compartment in preparation.

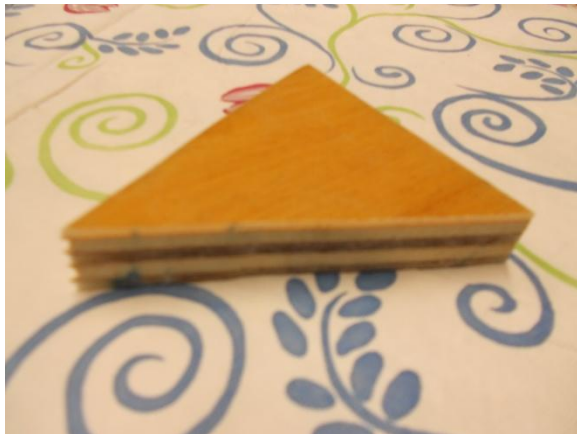
I took ¼ inch plywood and layered on cloth, roving, cloth, roving, and cloth with epoxy. I made a "sandwich" material with the fiberglass layers outside and two layers of plywood inside. I laid up and placed sandbags on top (sitting on plastic sheets). I felt there would be no way water could attack the plywood once installed; the material is not intended to be installed where it would be constantly exposed to water anyhow. A small piece showing cross section:

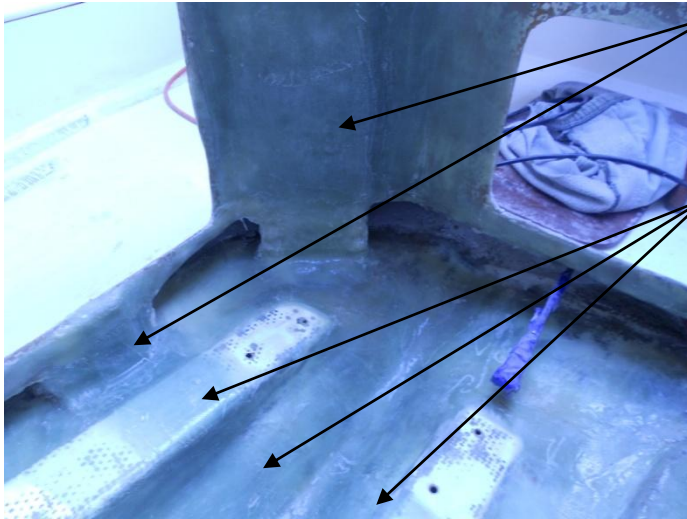
This is the aft starboard corner. The reinforcing layers of cloth on the stringers have been ground away where the motor mounts will sit.

Reinforcing material panels are glassed on here.

Layers of glass cloth cover the stringers here.

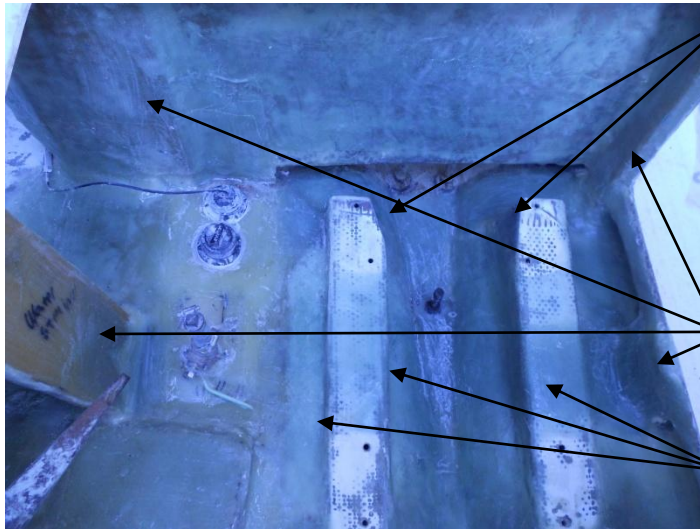
This is the forward engine compartment wall.

Cut faces of stringers covered with glass and cloth.

Reinforcing material.

Layers of cloth on stringers and bilge.

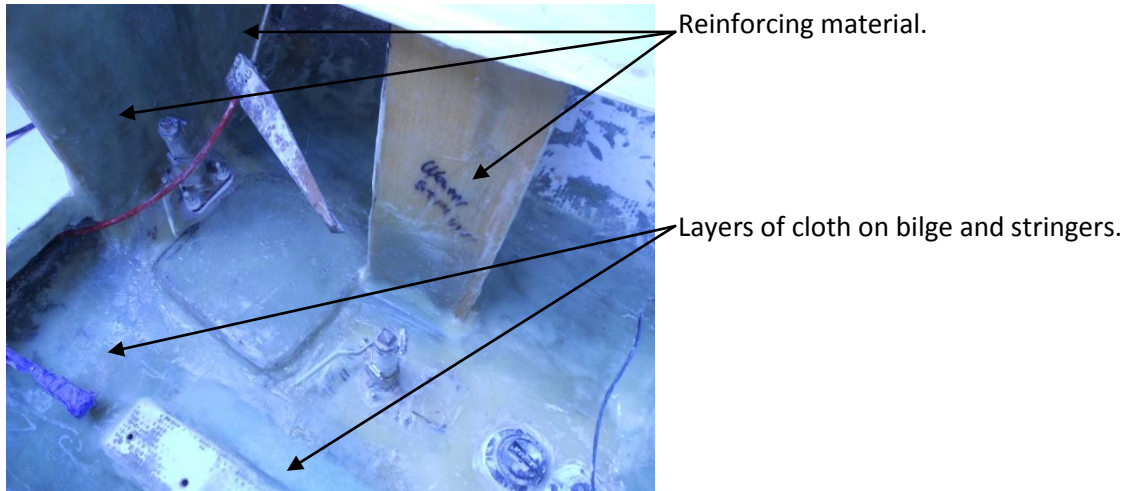
This is the port aft engine compartment wall.

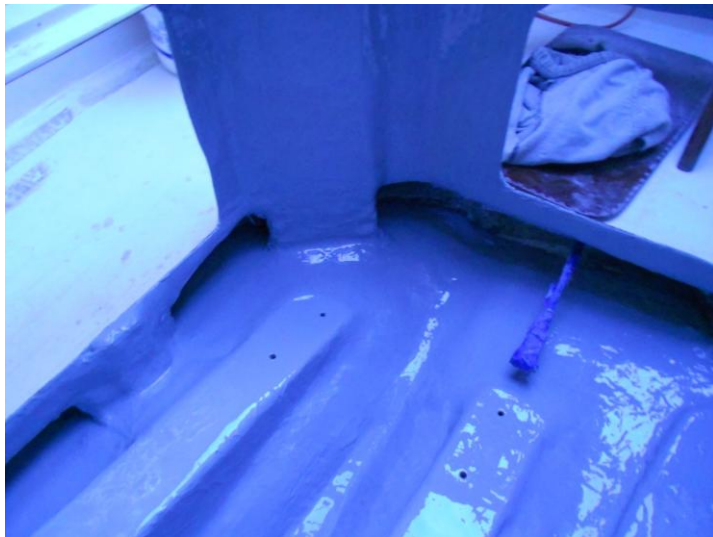
This is the aft end of the engine compartment after painting.

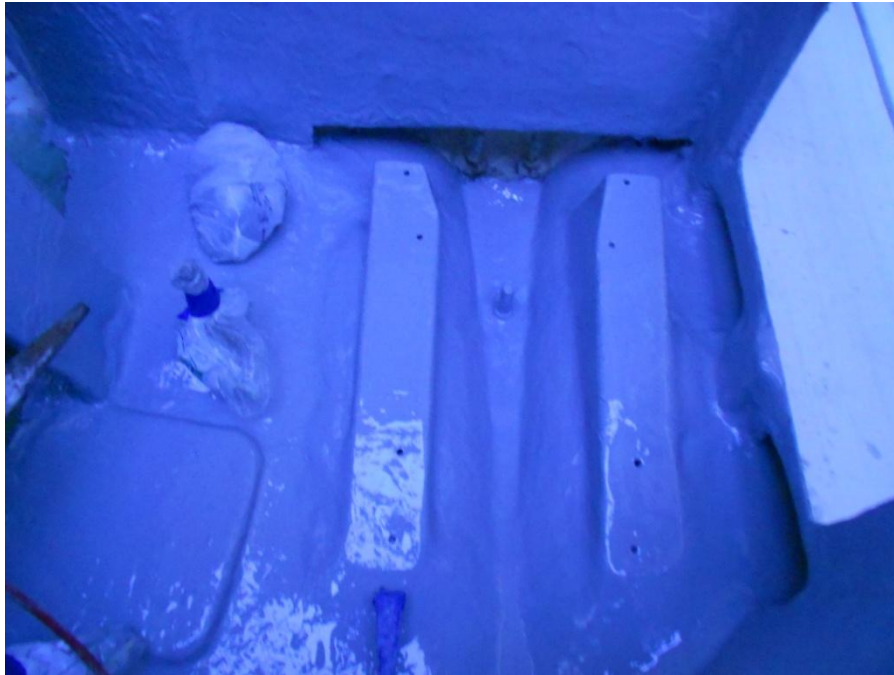
This is the forward end of the engine compartment after painting.

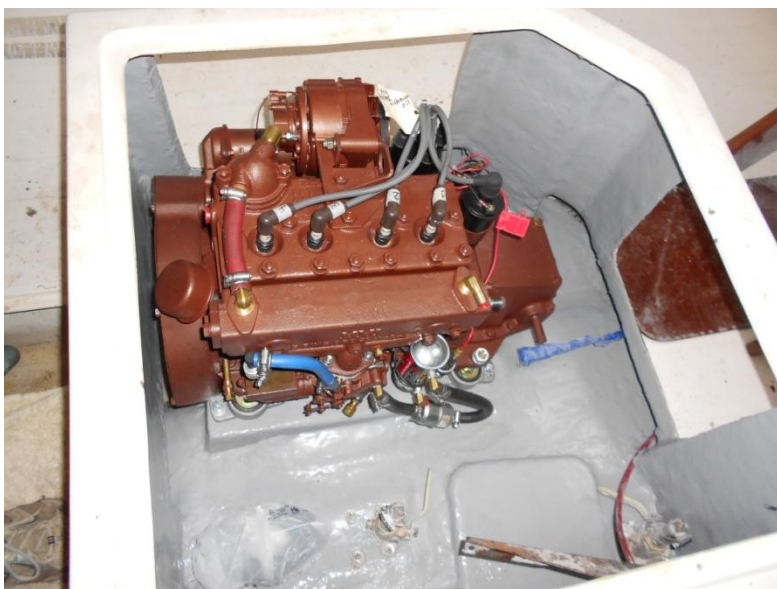
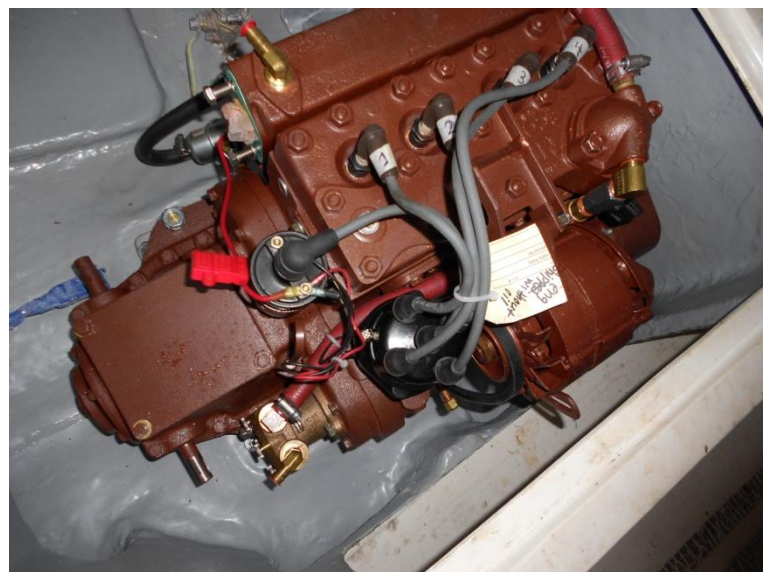
The Moyer Marine Inc. new block replacement engine was then set; the motor mounts were replaced with new.

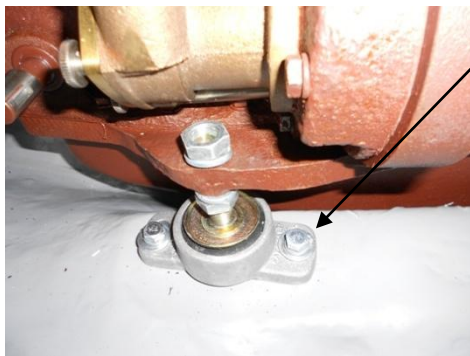
For some reason, the stringers had two slices cut out of them at an angle at the forward end; apparently to accommodate the flywheel and cover. The odd thing is that these cuts were not covered by fiberglass cloth. The lag screw brackets for three of the four motor mounts were quite solid; the starboard aft mount wood was "punky". This was excavated with an allen wrench in a drill; soaked with acetone and vacuumed out several times, and then filled with epoxy mixed with ground fiberglass. I thought I got both holes; apparently I missed the forward of the two holes: the lag screw would not tighten down after the engine was set.

This is the motor mount where I missed filling the forward "punky" hole – the forward lag screw does not hold anything and must be addressed (part of propeller shaft alignment).
